## 50SiMnVB 壳体裂纹原因分析

**摘要:** **目的** 分析某产品壳体在热处理后, 存在“周向”环形裂纹疵病的原因。 **方法** 通过宏观和微观观察、金相组织检查和化学成分分析检测、加工过程分析、验证试验等, 确定了壳体裂纹疵病的性质和产生的原因。 **结果** 该疵病是由于收口模引模角偏大, 经连续生产时收口模由于磨损产生挂腊, 并逐渐加重, 使口部引模角位置摩擦力增大, 导致毛坯收口后距口部 70 ~ 75 mm 位置 (机加后为 50 ~ 55 mm) 逐渐形成环形“折叠”。对未收口壳体修改收口模引入角由 20° 改为 10°, 经验证, 在收口过程中没有产生局部金属堆积变形, 消除了口部折叠, 彻底解决了收口“折叠”问题。经过热处理、机加、磁力探伤考核, 未出现壳体口部裂纹问题。 **结论** 收口毛坯折叠是产生壳体口部淬火“周向”裂纹的直接原因。

## Cause Analysis for Cracks in the 50SiMnVB Shell

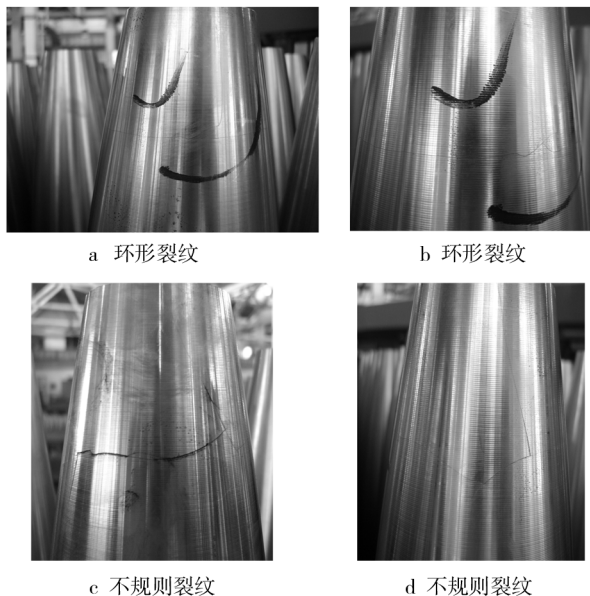
该壳体首批机加到“车全形”工序,目测发现分布在距口部50~55 mm位置,存在横向环形裂纹,见图1。理化分析结果判定:“收口折叠引起的淬火扩展裂纹,折叠深度0.21 mm,扩展裂纹深度0.27 mm,组织为回火索氏体”。金相分析见图2。

图1 横向环形裂纹

1) 除了原材料的冶金过程可能带来一些缺陷外,热加工不当所造成缺陷都会造成后续热处理(淬火)时形成裂纹等疵病。锻件毛坯形成的裂纹是不易被发现的,所以裂纹的扩展只有在随后的淬火过程才能显著地暴露出来。机加毛坯一经淬火处理,将会使原来存留的裂纹扩展,使其暴露于钢件的表面。根据成品壳体裂纹分布位置规律性,且和收口毛坯口部“折叠”位置基本一致,因此工艺加工问题是主要原因,收口毛坯口部“折叠”是造成热处理时淬火“周向”裂纹的主要原因。

1) 对未收口壳体,修改收口模引入角:由20°改为10°。经验证,在收口过程中没有产生局部金属堆积变形,消除了口部折叠,彻底解决了收口“折叠”问题。经过热处理、机加、磁力探伤考核,未出现壳体口部裂纹问题。

2) 对已收口未热处理壳体毛坯,采用机加将口部“折叠”车掉。经过热处理、机加、磁力探伤考核,未出现壳体口部裂纹问题。

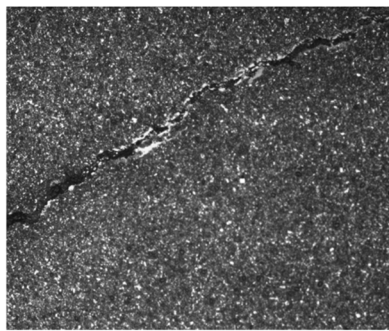
图2 折叠扩展裂纹(×200)

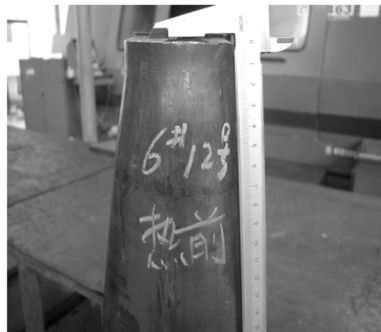
测量热处理前收口毛坯距口部70~75 mm位置(机加后为50~55 mm)存在环形“折叠”,见图3<sup>[1-5]</sup>。判定结果为:收口毛坯口部表面疵病为“折

图3 口部折叠毛坯

2) 壳体口部裂纹的主要原因是收口毛坯折叠造成的,从毛坯投料顺序看,收口毛坯折叠是生产过程中逐步产生的,且由轻到重、由浅到深。分析认为,折叠产生的原因是收口模引模角偏大,经连续生产时收口模由于磨损产生挂腊,并逐渐加重,使口部引模角位置摩擦力增大,导致毛坯口部逐渐形成折叠<sup>[6-10]</sup>。

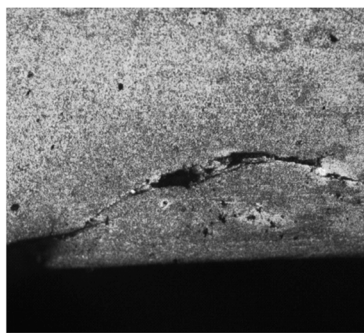
叠”,组织为珠光体+铁素体,深度0.3~0.5 mm,金相分析见图4。

图4 折叠毛坯金相(×100)
